Seagrass bed preservation through the reduction of land-based sources of pollution in Tamarindo, Culebra, Puerto Rico

Final Report – July 2022

TAMARINDO BEACH REHABILITATION PROJECT		St. Recinto Sur #251 San Juan, PR 00901 www.tetratech.com

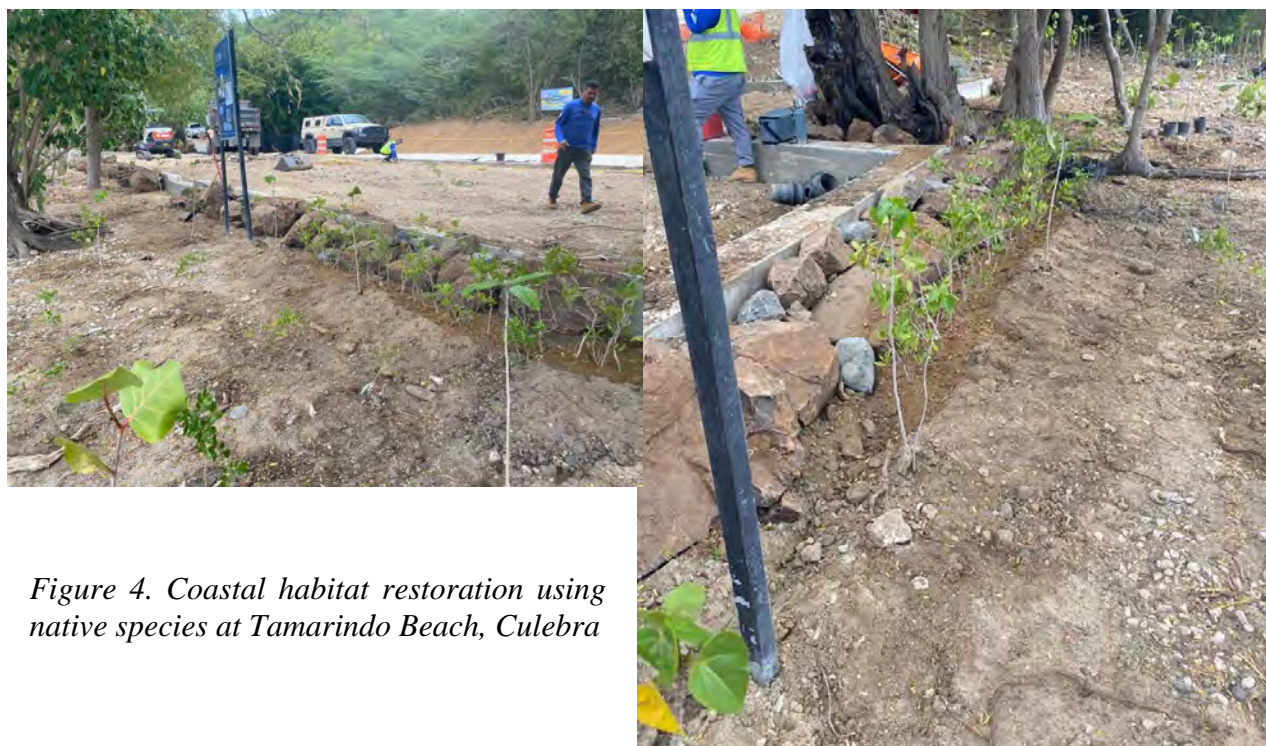
Figure 4. Coastal habitat restoration using native species at Tamarindo Beach, Culebra

Coastal habitat restoration: In order to restore coastal habitat, PDC planted a total of 650 individual plants from the following species: *Conocarpus erectus*, *Coccoloba uvifera*, *Cordia rickseckeri*, *Tabebuia heterophylla*, *Thespesia populnea*, *Terminalia catappa*, and *Guaiacum officinale* (Figure 4).

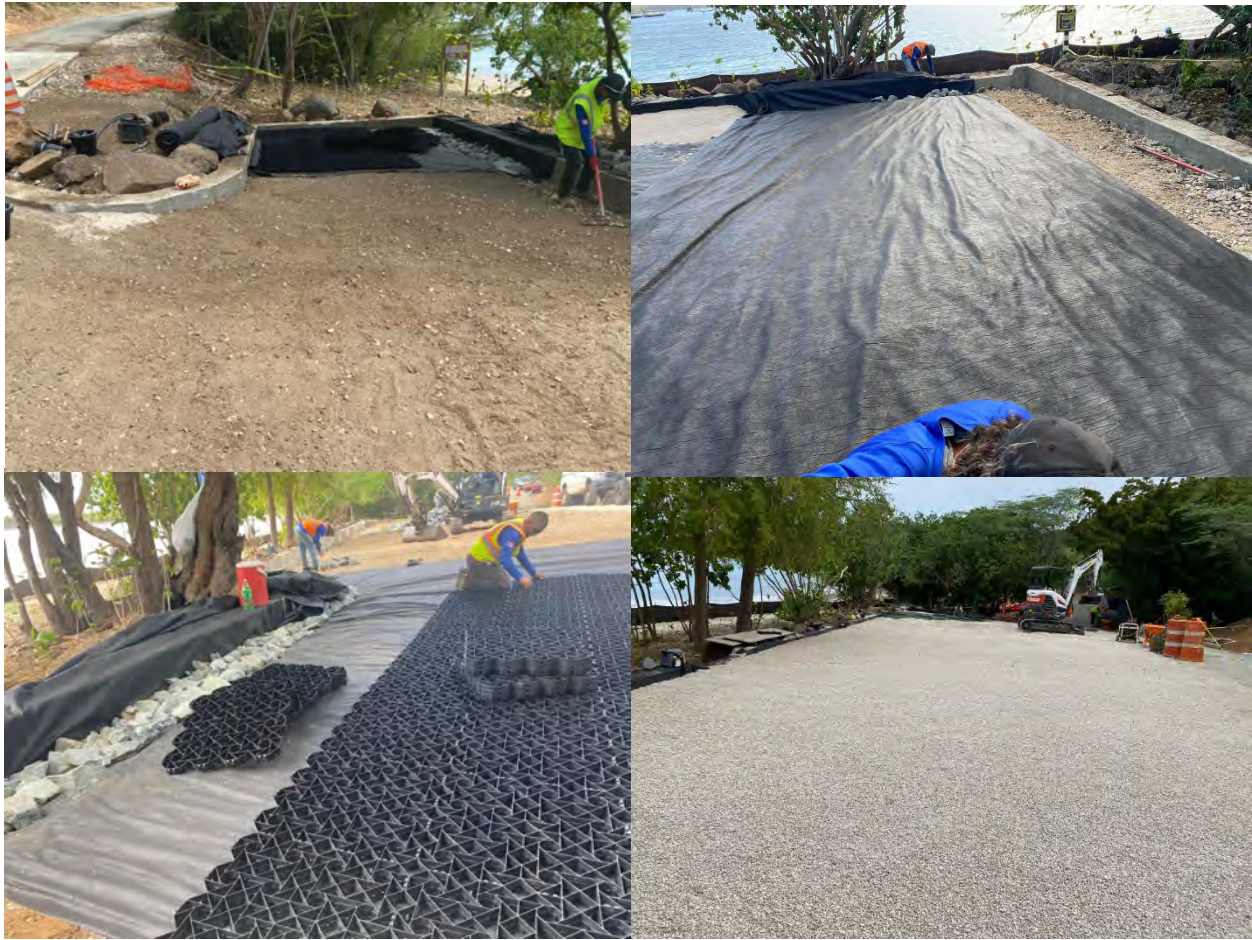
Figure 5. The process of developing the permeable parking lot at Tamarindo Beach.

The permeable parking lot was developed (Figure 5). As there is a kayak company with a trailer that parks at the beach on a daily basis, a parking area specifically for this trailer was created to provide more space in the parking area for locals and visitors.

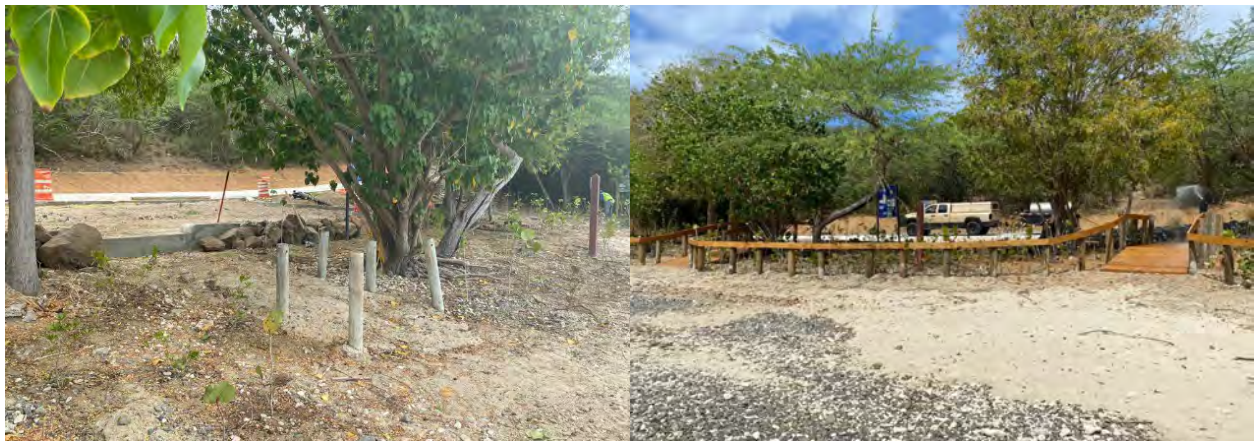
Figure 6. Previously installed and damaged wooden posts (left) were removed and replaced with new wooden posts and wooden boardwalks (right).

Delineation of public access areas: Previously installed and damaged wooden posts (Figure 6) were removed and replaced with new wooden posts and boardwalks to guide pedestrians to the beach without disrupting existing and newly planted coastal habitat.

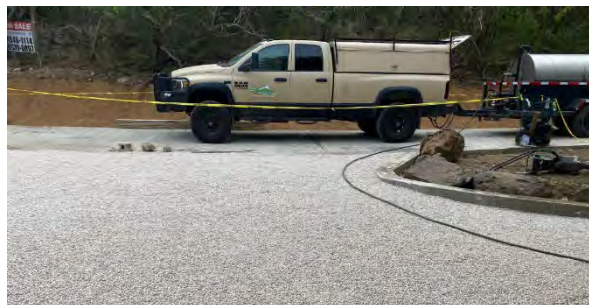
Figure 7. PDC water truck used to irrigate planted trees. While irrigating, PDC personnel also review functionality of the implemented best management practices and apply maintenance as needed

Follow-up visits to ensure proper maintenance and evaluate functionality: PDC has been conducting follow-up visits for irrigation and maintenance of the BMPs (Figure 7). All implemented BMPs, including the permeable parking lot, the wooden boardwalks, the paved access road, and the delineation using the wooden posts and boulders are functioning as intended. PDC has observed visitors in the area and have noticed that the kayak trailer is consistently parked within its designated parking spot, and that visitors are not stepping on coastal vegetation and are instead using the boardwalks to enter the beach.
