Mangrove Restoration following Hurricane Dorian

Craig Dahlgren, PhD
Perry Institute for Marine Science

September 13, 2022

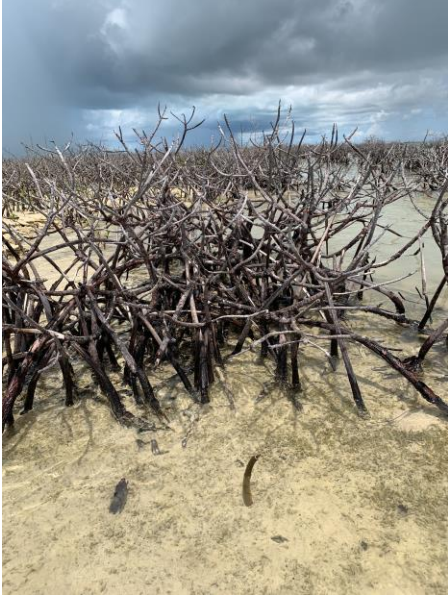
Figure 2. Mangrove propagule (foreground) planted in proximity to a dead dwarf mangrove off Abaco.

Mangrove plantings were conducted at four locations for Grand Bahama and three for Abaco, across a diverse range of mangrove types including large mangroves on over wash islands, large mangroves fringing creeks and dwarf mangroves on intertidal flats. In all locations, propagules were directly planted (Table 2, Fig. 2) with propagules collected from Grand Bahama being planted at restoration sites off Grand Bahama and Propagules from Abaco being planted at restoration sites for Abaco. At each restoration site, propagules collected from a particular site were planted together in a plot separate from propagules collected from other sites, usually with multiple plots at a site. This will allow us to track survival and growth of different source populations at each restoration site to determine if there are differences in success of plantings using different sources under different conditions and allow us to improve the success of future restoration efforts.

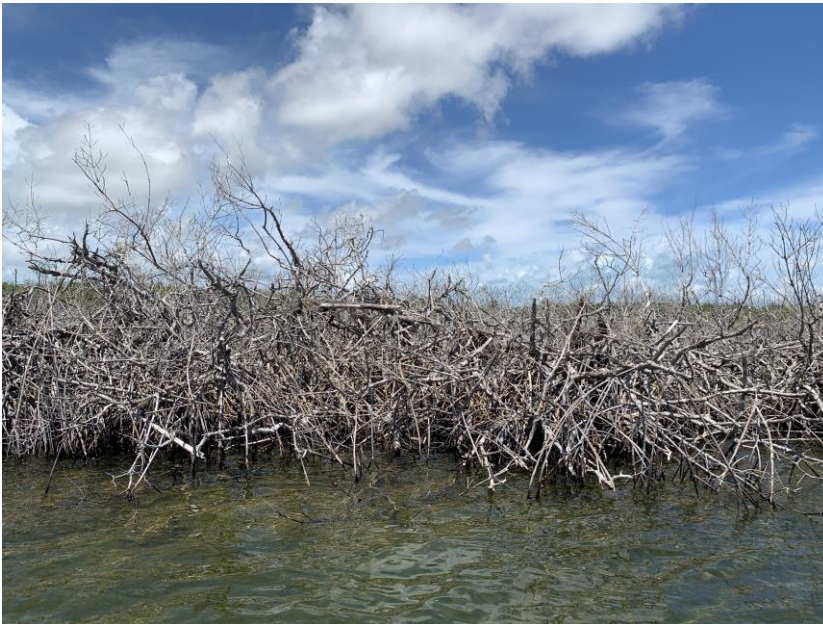
Figure 3. Example of a mangrove area of Abaco where direct planting was not possible along the outer edge of mangroves due to water depth and shallowed depths located within the matrix of dead mangroves was not accessible due to high density of dead roots and trees. Additional photos and video from the mangrove restoration for Grand Bahama are available using this link:

There were two instances however, where some parts of a site were inaccessible to plant propagules directly into soils. In one case for Abaco, parts of a site had mangroves areas that were inaccessible due to high root densities that were impenetrable at depths needed to plant mangroves at part of the site (Fig. 3), and at one site for Grand Bahama shallow water depths prevented boat access and deep muds prevented walking into parts of the site.

In both cases where parts of a mangrove restoration site were not accessible, a subset of propagules at the site were not planted into the substrate but were dispersed using other means. In these areas, we attempted experimental restoration without planting directly into the soil using a “facilitated recruitment” strategy of natural restoration. In the dense root structure of Abaco, approximately 1,000 propagules were dispersed by simply tossing propagules into the mangroves to allow them to naturally become trapped in the roots and recruit to the sediment to take root. In location with shallow water but deep mud on Grand Bahama, we released ~2,000 propagules in tidal creeks on an incoming tide to be transported to the interior of the mangrove island.
